## **WP# 27 Yellowing of Polycarbonate Plastics – Sept 9, 2021**

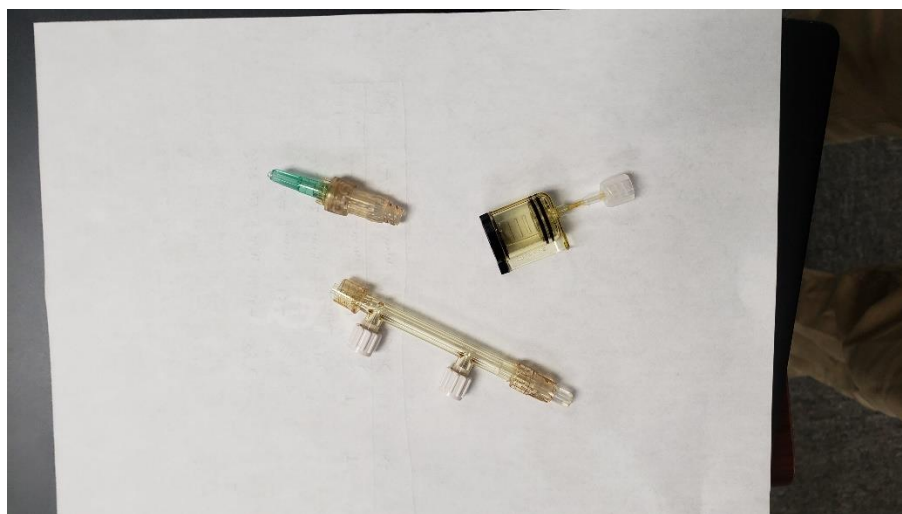
Figure 1: Samples before de-yellowing.

The case study was performed on three small plastic samples: pieces of medical devices which had been yellowed by chlorine dioxide during a decontamination cycle. These devices were made from polycarbonate and urethane tubing compounds and were of different shapes and sizes. Instead of the original Retrobrite mixture, 40 volume cream developer was used. According to an article by Whitson Gordon on the hobbyist website [www.howtogeek.com](http://www.howtogeek.com), this hair product has been found to have a similar makeup to the original Retrobrite recipe, and is similar in effectiveness while being easier to obtain.

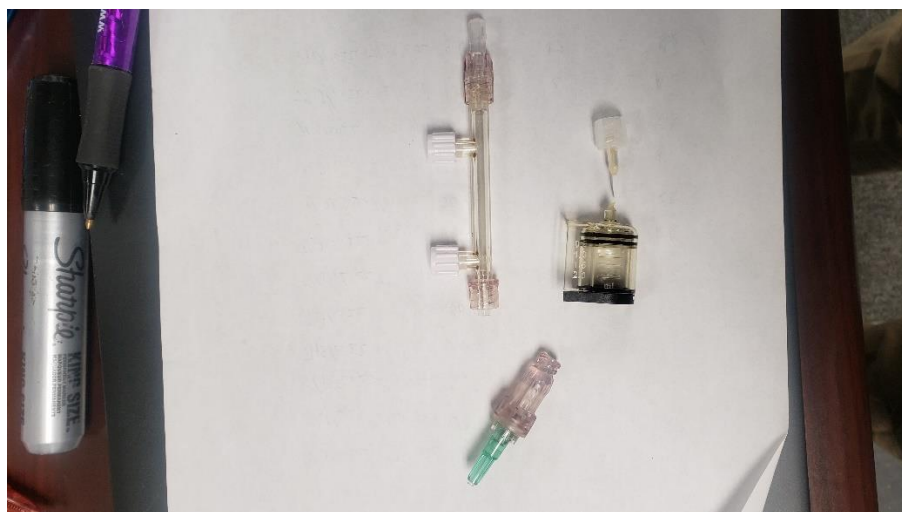
Figure 2: Samples after de-yellowing.

The samples were observed to have considerably less yellowing after the method was applied. However, it was also noted that the method was not equally effective on each of the plastic pieces. There were a few factors that could have caused this. The exact type of plastic was unknown prior to testing, so material differences could be the cause. Two of the pieces have an inner surface, which may not have gotten sufficient exposure to the mixture of UV radiation. Further testing is needed to determine the exact cause of the difference in yellowing.

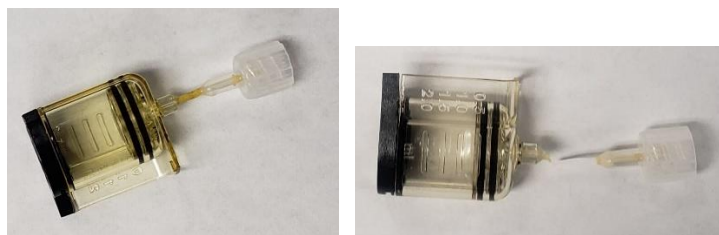
Figures 3a and 3b: Sample A before and after

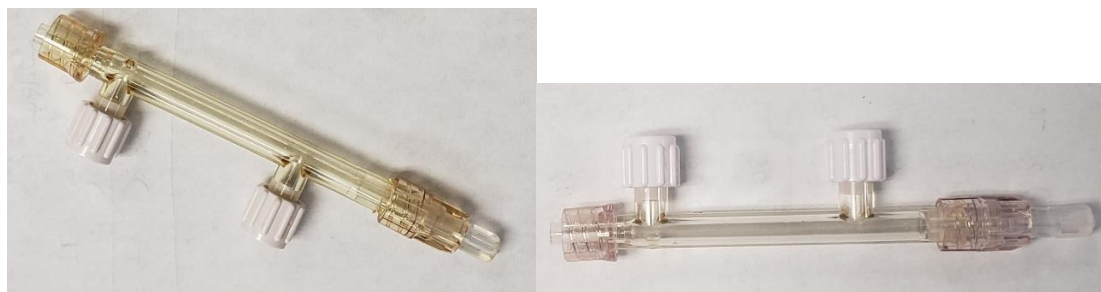
Figures 4a and 4b: Sample B before and after

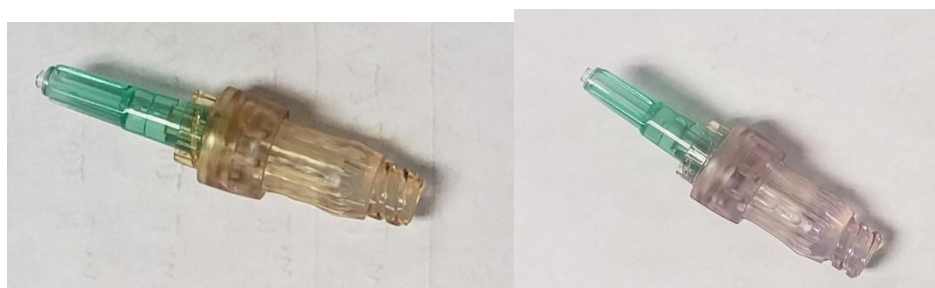
Figure 5a and 5b: Sample C before and after
